Quell QPI9010 Dual Sensor Smoke Alarm Recall Identification Guide

(for New Zealand sold units)

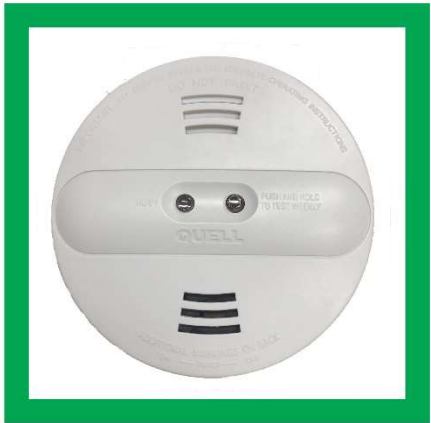
Affected

Look for this pill shaped design on the front of the unit. This feature is slightly raised and is unique to this alarm.

If your alarm matches this design, please proceed to the next step.
